# Manhole Inspection Summary

Manhole # S49M\_\_016MH

**Inspection** ☐ Is Incomplete Rating: **3) Fair**

**Location** Address: **825 alley fait hudson**

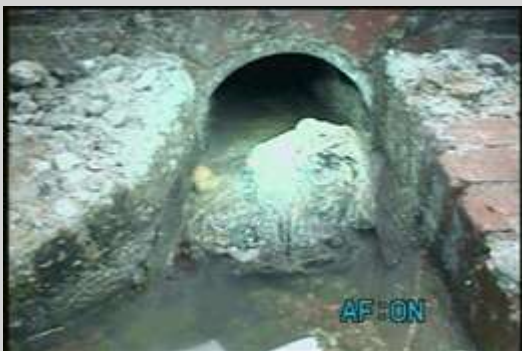
3 O'Clock Inflow

8 in. Circular Gravity Sewer  
Pipe In @ 3 O'Clock

Pipe Height: **0** (in.) Direct  
Pipe Material: **Clay** ☐ Pipe Lined  
Invert Depth: **8.25** (ft.) Flow Characteristics: **Slow**  
Deposits: ☒ **None** ☐ Mud ☐ Sludge ☐ **Debris** ☐ Grease  
Silt Depth: **0** (in.) Deposits Extent:  
Infiltration: **None** Pipe Seal Cond: **Unknown**
